LIVESTOCK AND VEHICULAR UNDERPASSES SUPPLEMENT TO FINAL REPORT 98 CASE STUDIES

LIVESTOCK AND VEHICULAR UNDERPASSES

CASE STUDIES

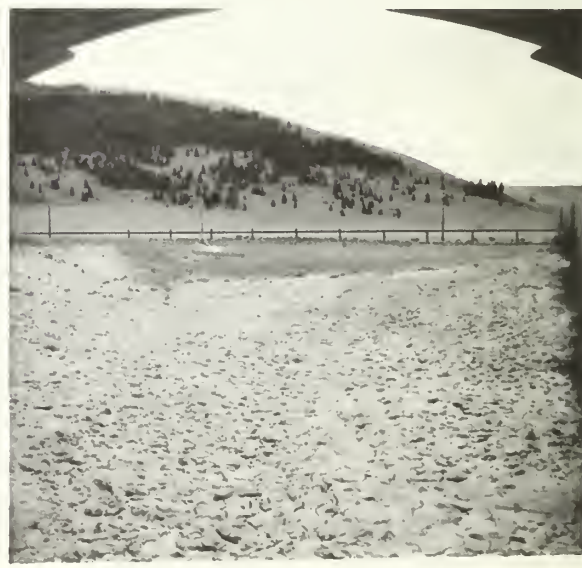
SPECIFIC PROBLEMS: Structure is much too small for large herd drives. Thirty individual ranchers belong to the Snowline Grazing Association and drive as many as 500 head at a time. It becomes a very boggy area during periods of runoff, and, although this provides bedding for the pipe, the soil does not contain enough gravel to keep a firm foundation.

Looking east from EAST ENTRANCE; water flows from East to West

ADEQUACY: Inadequate due to undersize and large volume of cattle usage. A larger arch pipe would have necessitated a raise in grade at that point. Stabilization of the pathway may have been possible with gravel or pavement.

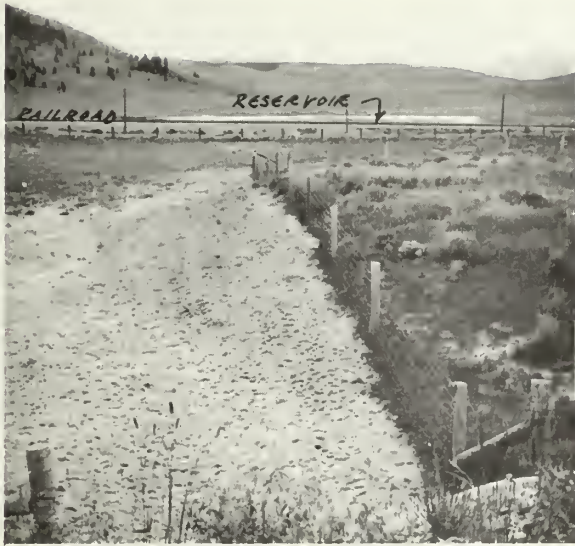
Looking west from WEST ENTRANCE; note length of low condition.

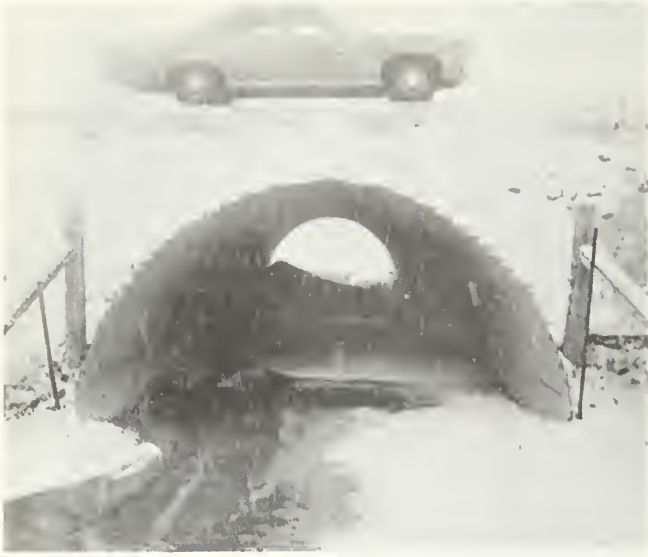
Stockpass snow conditions; Monida
Pass, Elev. 6800. 5/12/70

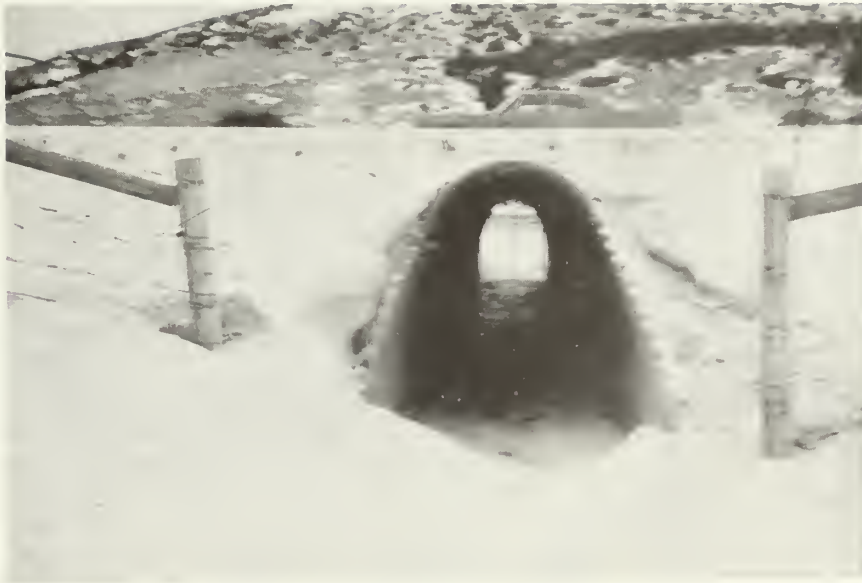
EAST ENTRANCE; photo taken 1/19/71 showing snow conditions, ice in pipe bottom.

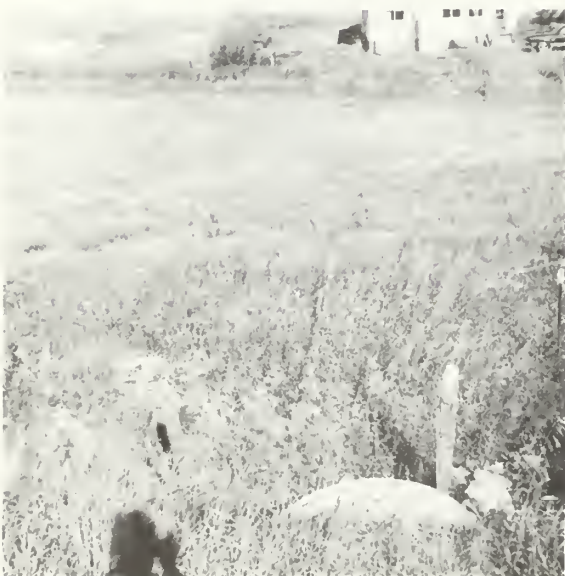
SOUTH ENTRANCE
Gate is in good repair
